Enhancement Concept Diagram Amazon Creek (Reach 8) South of Union Pacific Railroad: **Alternative A**

Drafts: June 2006
Produced by LCOG

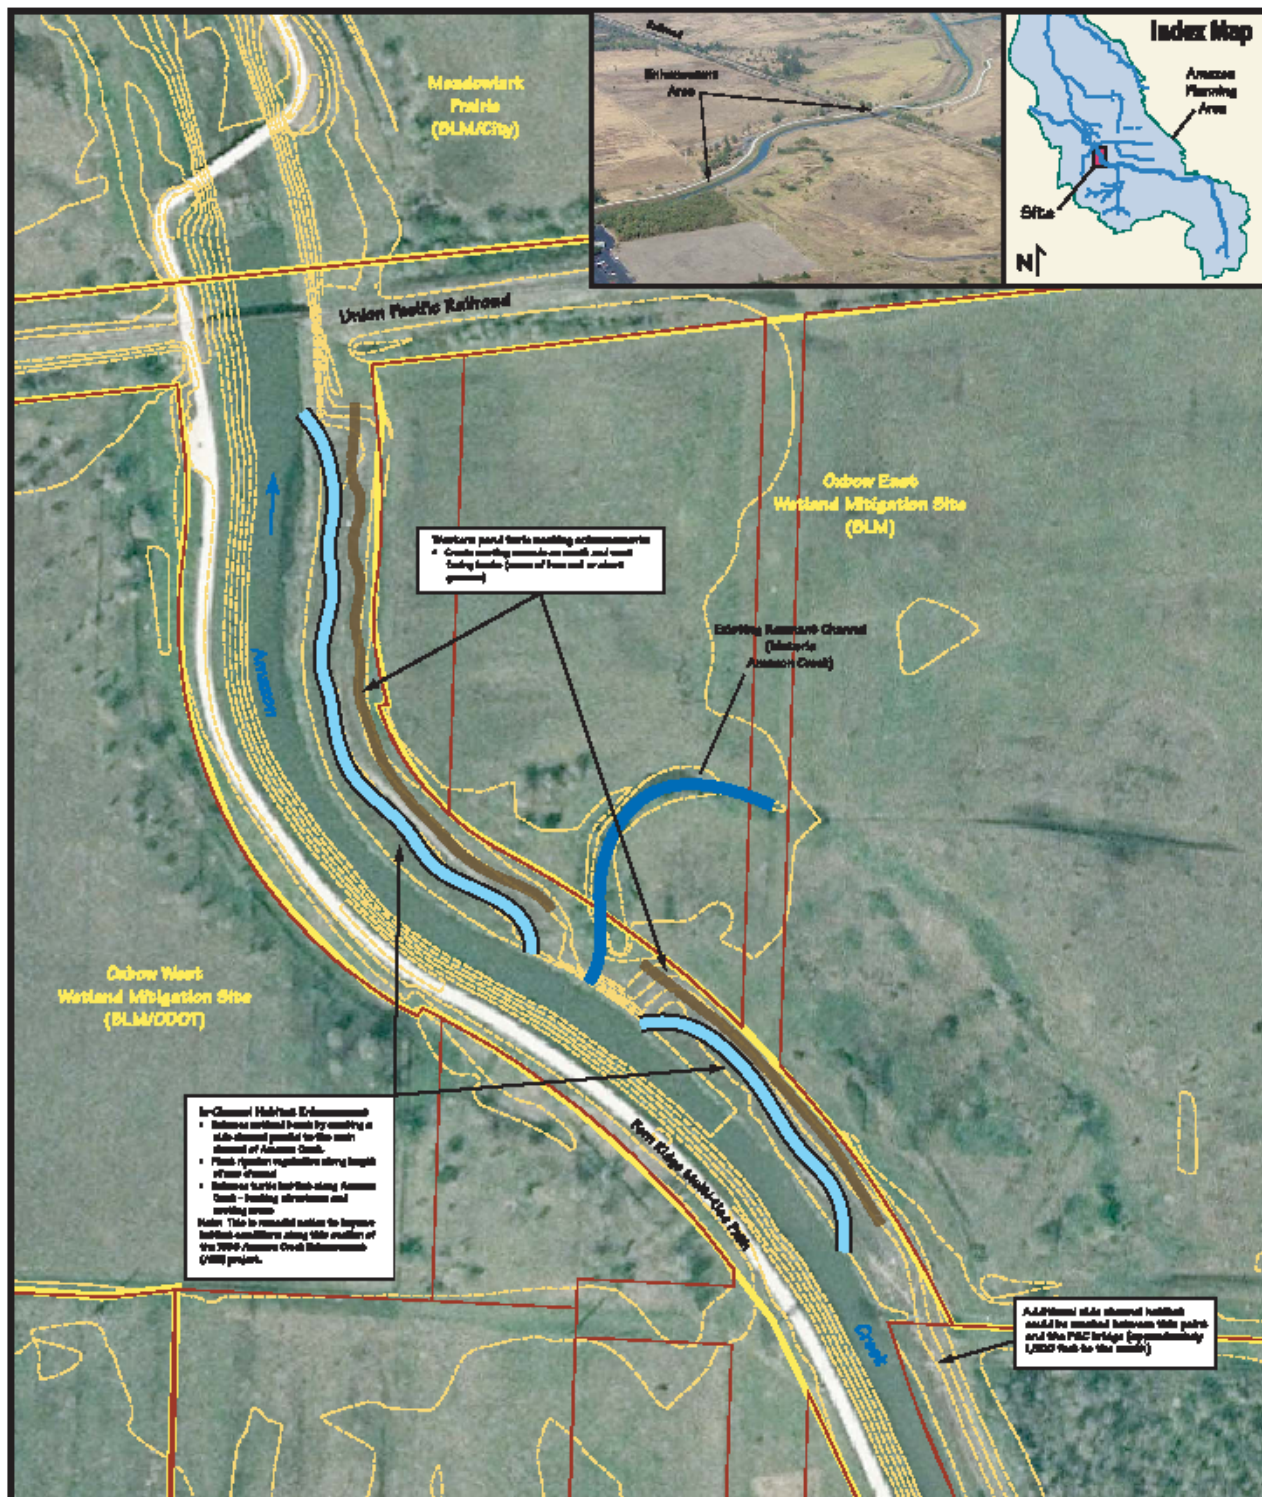
Waterway Assessment Results

Amazon Creek (South of Railroad)	Physical Condition	Water Quality	Natural Resource	Restoration	Total Points
Highest Possible Score	40	40	20	30	130
Existing Score	17	21	22	24	84
Projected Score *	21	39	22	24	107

*Projected score is based on successful implementation of the enhancements proposed in the alternative shown.
